The Inspektoren Residential Area

Work Package 4.1

Environmentally adapted refurbishment

– Report –

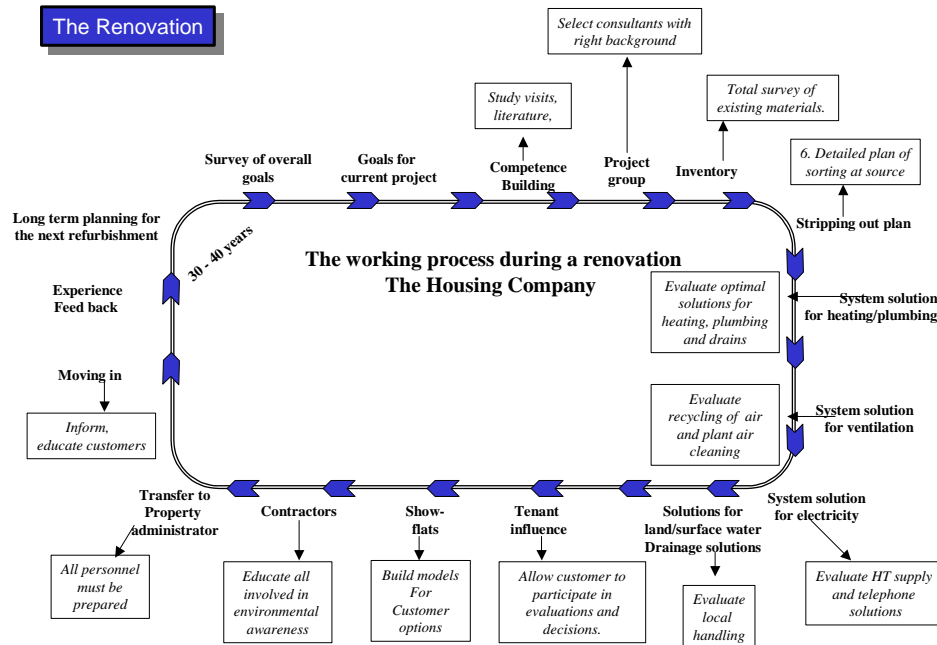
Figure 1. The construction process

The process is illustrated by a time plan in the form of a “race track” which shows all the phases from the first pre-planning and goals to the transfer to the property administrator and experience feedback.

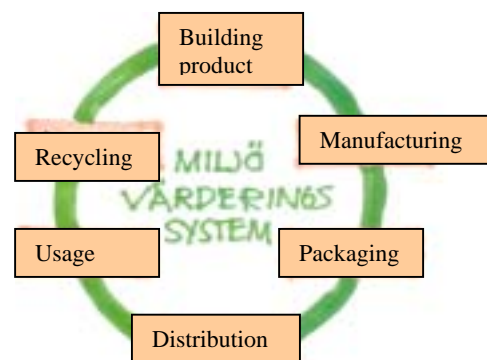
Figure: Environmental evaluation system

Our search was successful at the Institute of Construction Ecology. A clearly understandable environmental evaluation system was being developed that was built around the "Natural Steps System Conditions". Products were not allowed which contained any of the substances on the lists of the National Chemicals Inspectorate (List of limitations, OBS list and classification list), nor were any potential emissions that could result in known health hazards. The handling procedures for waste products that could become hazardous were also laid down.

The evaluation gave rise to five classes of product:

1. Recommended in first place
	2. Recommended in second place
	3. Acceptable
	4. To be avoided
	5. Unacceptable

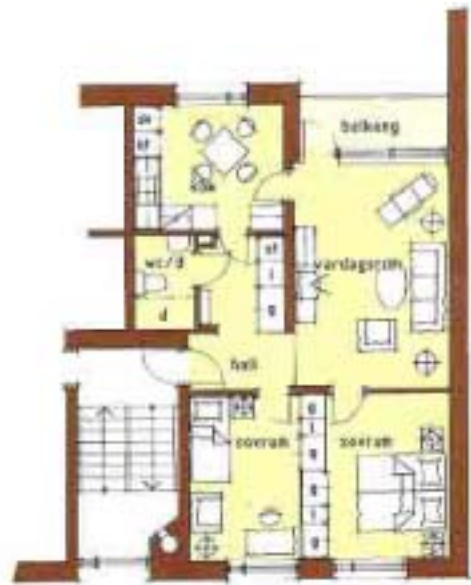
Cautious refurbishment

The flat has been refurbished to a very limited degree. The guiding principle was to keep everything that was not worn

The refurbishment included:

- Lowering the floor in the bathroom
- Installing a wet area cassette
- Change to wider bathroom door
- Extractor hood in kitchen
- Replace fridge with fridge/freezer
- Re-paper one bedroom and hall
- Re-paint kitchen
- New floor and wall covering in bathroom
- Change electrical installation, put in special devices to reduce electromagnetic fields

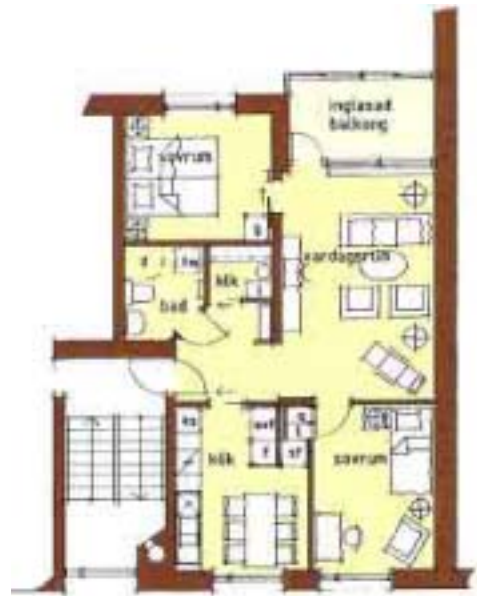
Normal refurbishment

The refurbishment covers what is normally carried out when older blocks of flats are renovated....

The refurbishment included:

- One bedroom facing the street has changed place with the kitchen
- New kitchen fittings with waste disposal unit and special cupboard for sorting at source
- New wardrobe
- Enlargement of bathroom
- Lowering of floor in bathroom
- Installation of wet area cassette and urine separating toilet
- New floor and wall covering in bathroom
- Parquet floor in bedroom

- Re-papering and re-painting
- Enlargement and glazing of balcony
- Change electrical installation, install special devices to reduce electromagnetic fields
- Installation of central vacuum cleaner

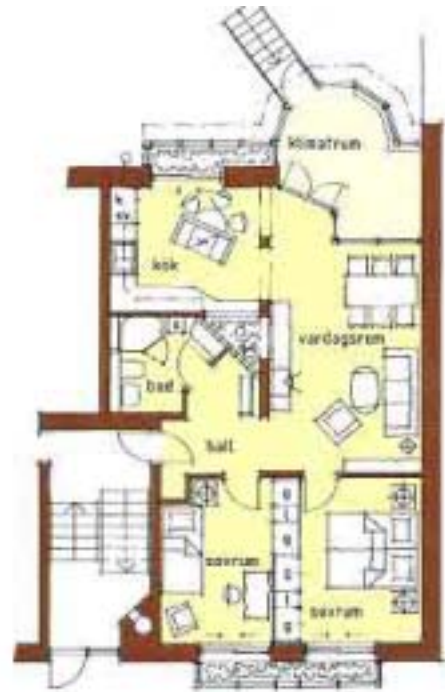
State-of-the-art refurbishment

The flat was equipped with the latest, state-of-the-art technology for recycling-oriented refurbishment:

The refurbishment included:

- Completely new kitchen fittings including cooling pantry with natural cooling
- Enlarged bathroom, urine separating toilet and special installations for water and drains
- Light prism with glass brick walls
- Climate partitions outside kitchen, living room and bedroom
- Tiled floors in bathroom, hall and climate room
- Ash parquet floor in living room and bedroom
- Re-painting using emulsion, egg-tempera, tempera and linseed paints
- Special plumbing installations for handling waste water and urine
- Plant filter in climate room and temperature/humidity controlled ventilation damper
- Special electrical installation, install special devices to reduce electromagnetic fields

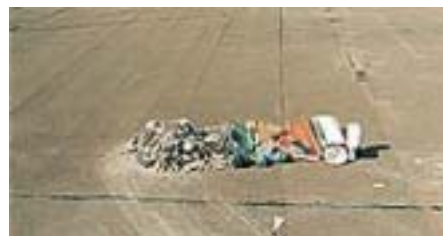
Cautious refurbishment

To give a picture of the amount of stripped out material involved in the different refurbishment alternatives, the material was sorted at source into three fractions, namely filling material, combustible material and recyclable material.

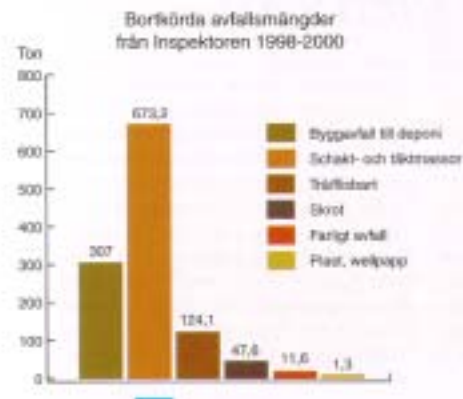
As shown in the diagram above, 307 tons of waste was transported for disposal. The project's goal was 20kg/m² total gross area, giving approximately 290 tons, so the goal was almost reached.
