The Inspektoren Residential Area

Work Package 4.1

Water and Drainage

– Report –

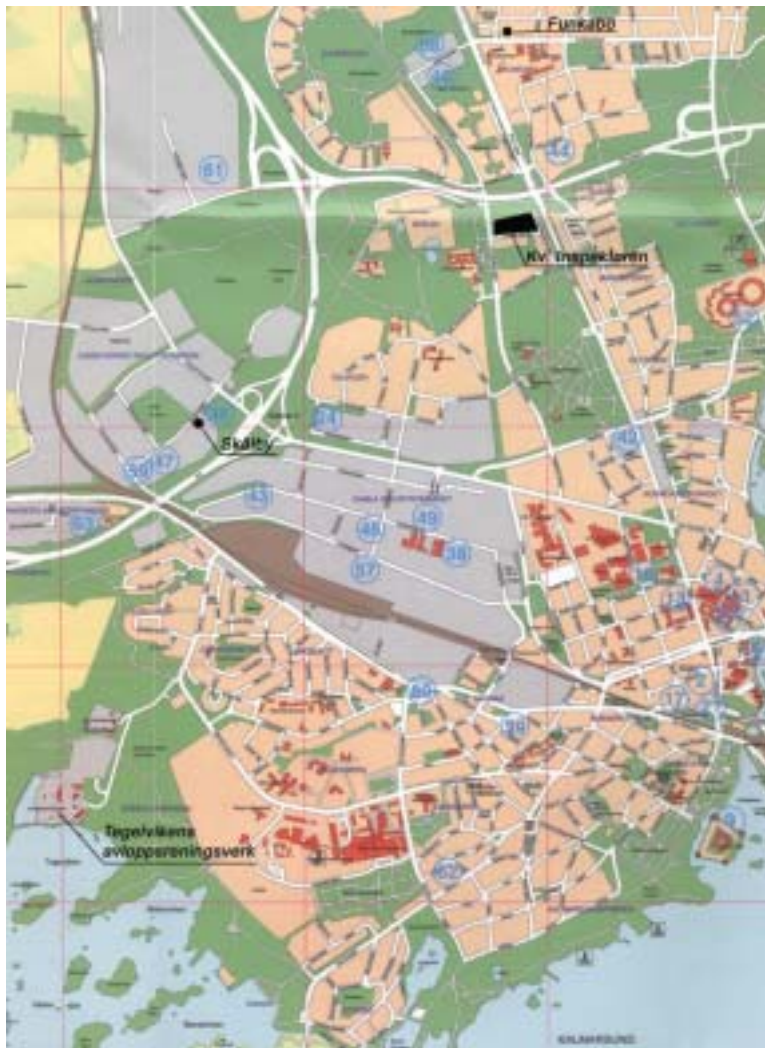
Figure 1. Map showing position of the various plants and the Inspektoren area

Water supply in Kalmar is based on ground water from the Nybroåsen area approximately 20 km south of the city. The raw water is alkalisated at the waterworks in Skälby but does not undergo any further treatment before it is distributed to the mains water network. When required the water can be chlorinated.

Waste water from Kalmar is piped to a modern sewage works at Tegelviken in the southern part of the city. There is a biogas plant at the works consisting of two sections: the first is made up of the sewage works' usual sludge treatment where the sludge is treated in a sedimentation tank (digester). The second section, which was originally a second digester but is now redundant, is now purely a biogas plant in which manure and abattoir waste decays for biogas production. The biogas produced here is used for powering vehicles.

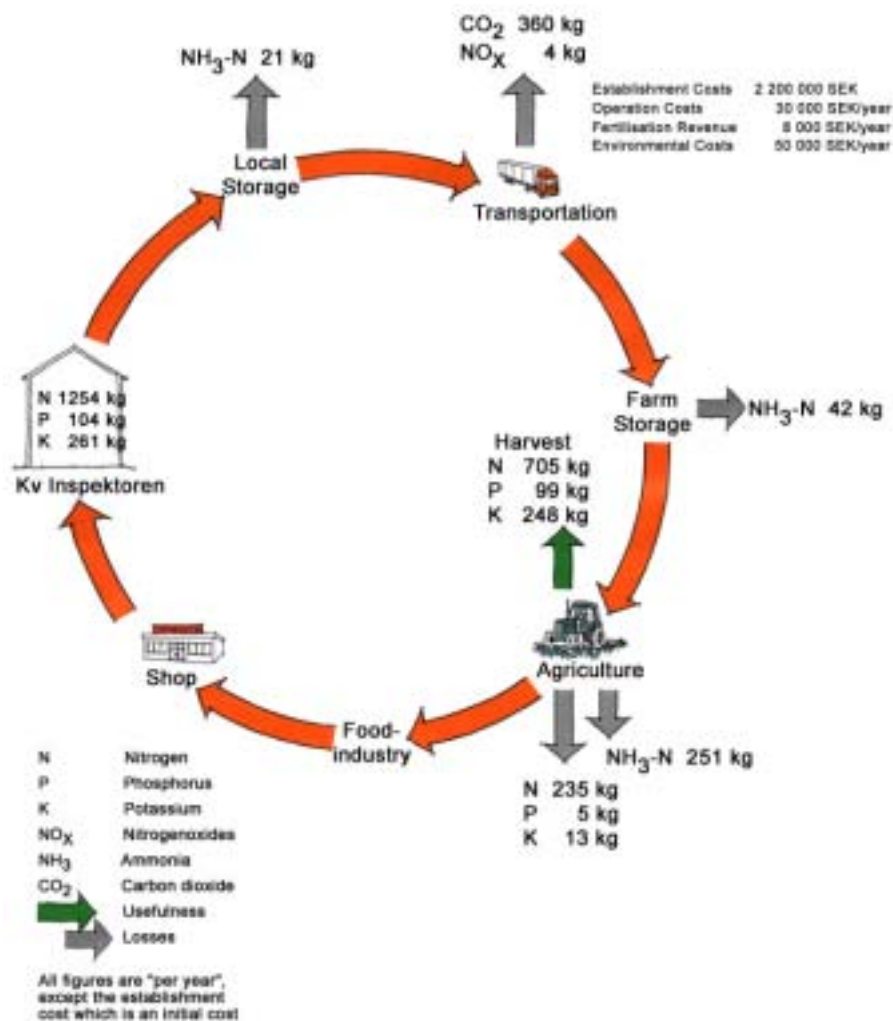
Figure 3. Lifecycle analysis regarding system solution with urine separation.

- System analysis in the form of a lifecycle analysis, **Figure 3**

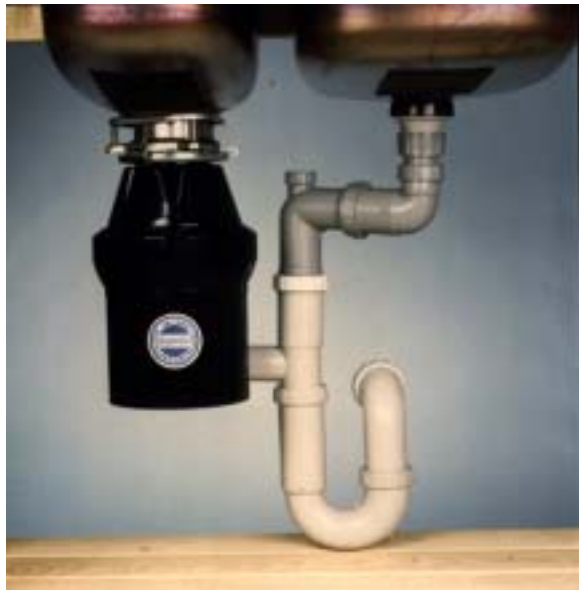
Figure 6. Kitchen waste disposal unit mounted under a sink

Disperator Model 77, Figure 6
