# The Inspektoren Residential Area

Work Package 4.1

## IT System

– Report –

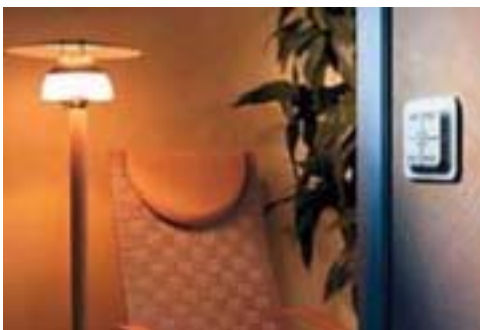
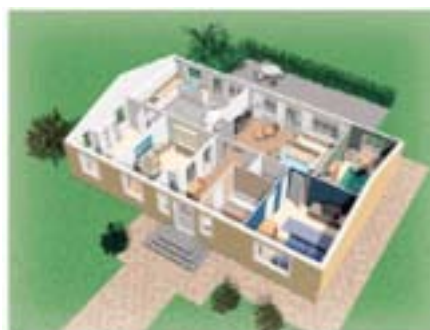
A Lexel IHC Control and monitoring system was installed in one of the state-of-the-art flats to show different levels of refurbishment.

The system is programmable and provides almost unlimited control of lighting, heating, ventilation and alarm systems. Lexel IHC has a smart infrastructure and it enables control, adjustment and adaptation as and when the need arises.

Control takes place using a low voltage system (24V) and all parts of the electricity network that are not in operation are inactivated. This provides a healthy electrical environment and improved safety, especially for children.

Here are some of the functions that have been installed:

- Isolators for cooker and certain sockets in the kitchen
- Night lighting in the bathroom and toilet
- Relay control of lighting in plant areas
